Volume 17, Issue 3

New Year 2008

## "Perseverance"

**A Grand River Valley Church is Resurrected from Ashes**

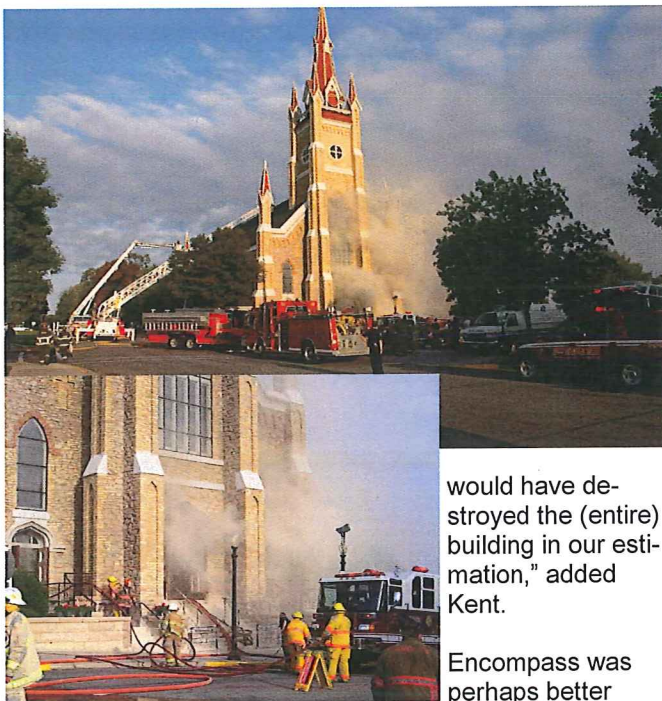
As a source of fuel for the fire, the floor and many of the pews were perhaps the most obvious loss. The main altar made it through the fire relatively unscathed, however a delicately carved butternut side altar was toppled and severely damaged. An organ installed in the mid 70's had to be replaced, as did the new air conditioning. "The new AC system had never been turned on before the fire," noted Kent Jones P.E. of Encompass Engineering. "One thing the church had going for it was the abundant plaster lining the interior walls. (And) if not for the fact that the masonry walls weren't combustible the fire

The fire department of Shakopee and thirteen other communities were called on to put out the fire.

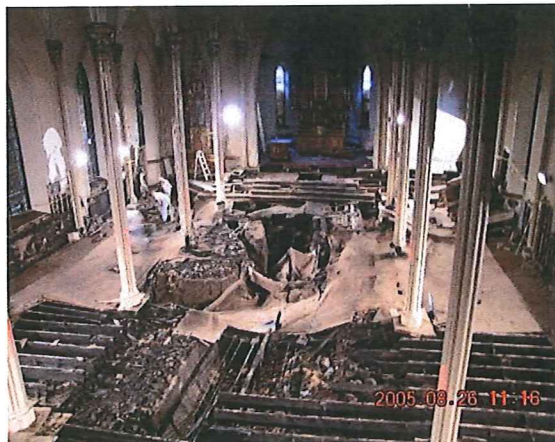
not be put out. "The floor had been furred with several layers to it," Father Stolzman explained. "Those layers provided fuel for the fire," he reflected. "And because the basement was basically a crawl space with a series of trenches cut through it, it was a very difficult fire to put out." In the end it took thirteen fire departments, eleven hours to help put out the smoldering fire. In an effort to provide relief from smoke damage, two of the historic stained glass windows on either side of the altar were sacrificed. Holes were also made in the roof and the fire was finally extinguished by twice flooding the crawl space and floor with water.

The fire smoldered and consumed most of the floor over a period of eleven hours.

This is when Encompass decided to recommend a step that is highly unusual in the field of building forensic inspection: The renovation would have to begin before the investigation had become complete. More specifically, the floor would have to be addressed before the top of the church could be more thoroughly evaluated. To complicate matters, it would not make sense to construct the floor without addressing foundation and utility related issues that could not be excluded. What could not be answered, is whether this would be money well spent, or simply thrown away; because completely rebuilding the roof and ceiling structure may in the end make the cost of the entire renovation prohibitive. The least disruptive solution was to eliminate the floor structure entirely and fill the crawl space with Flow-crete; a low strength concrete product that would lock in the footings that rested under the columns. This also would save significant costs in manpower and any necessity for heavy equipment that might do more harm than good. "Thinking ahead as we did this," said Kent Jones, "we planned for the construction of hollow trenches within the concrete to accommodate future mechanical and electrical components." In the end 50 truck loads of Flow-crete were required for the new floor.

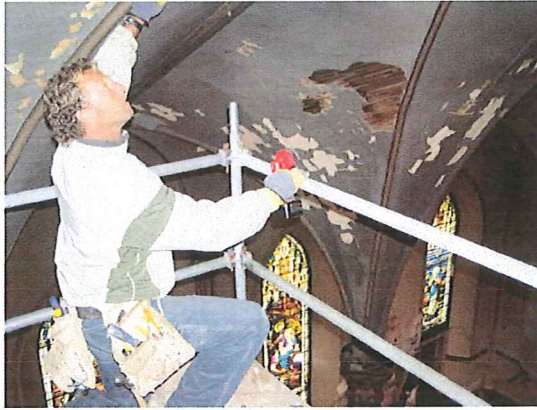
some of the plaster through examination and subsequent lab testing was determined to have sustained serious damage. However what was remarkable and perhaps a testament to plaster's superior fire-resistive qualities is that the system of wood structural support behind the plaster also made it through the fire relatively unscathed.

Jones. Compromised areas were marked with red spray paint. "We thought that perhaps some of the loose plaster could be salvaged with a combination of washers and screws. Patching and flat work would then be skim coated with a layer of Dryvit Primus and reinforcing mesh." In the end it was determined that this process

Inspecting the groined vaulted ceiling

would be too extensive. This was also exacerbated by smoke damage that continued to linger long after the smoldering fire had been extinguished. "I'm glad they decided to tear off the old plaster," said Rich Furry, Field Superintendent for Custom Drywall, who was in charge of renovating the plaster work. "There were spider cracks and failures all over the place and the smell would have never subsided without doing something about it," added Rich.

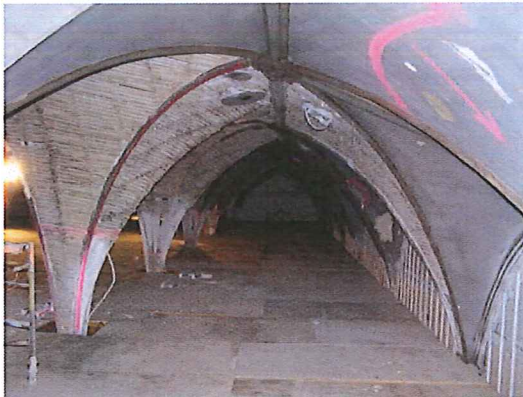
Removal of plaster revealed the wood laths that had been nailed in place 150 years before. Note the "dance floor" staging built high above the sanctuary to expedite the renovation.

The rehabilitation began by carefully taking down the plaster from the walls and the ceiling. What was left of the ceiling was the skeleton of the many wood laths that had been individually

Staging beneath the ceiling was in itself a challenging proposition. Scaffolding was set to provide for a platform floor directly below the ceiling some forty feet above the sanctuary. This was termed a "dance floor" by the Custom crew because the plywood floor was constructed without gaps and the resulting curves of the columns and ceiling resulted in a kind of ballroom appearance. Still more scaffolding was used on top of the dance floor to get to the upper reaches of the complex ceiling.

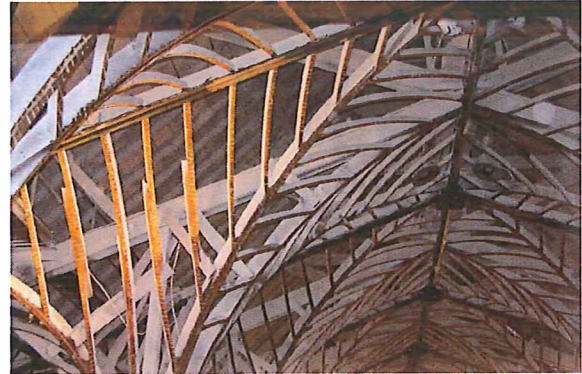
The wood framework skeleton that supported the complex ceiling.

Behind the plaster ceiling a system of wood framework was revealed that was tied into timber trusses that were spaced fifteen feet apart. The roof itself was supported by cross members equally spaced between the trusses. The columns that rose through the sanctuary were tied into the bottom chord of the trusses. Some thought had been given to removing these columns in the renovation, to provide an unobstructed sight line to the altar. It was also determined that they were not designed to support the weight of the roof in the original construction. However what had become evident in the investigation is that the roof had sagged over the years and that some of the roof's load had indeed been transferred to the columns. All of this notwithstanding, their removal would have taken a lot away from the aesthetics of the original architecture and may have associated even more costs to renovating the roof.

Although the wood structure behind the plaster survived the fire, the smoky smell had permeated it. This was resolved by coating the wood with inhibiting coating that sealed in the smell before the plaster renovations began.

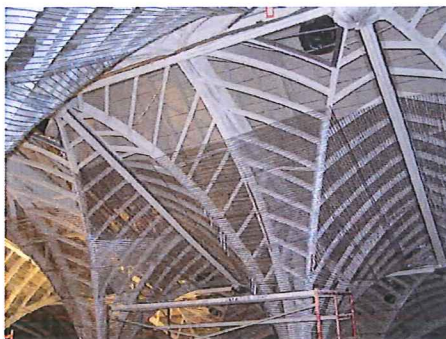
*Ribbed lath was used to replace the wood lath because of its stiffness and ability to span between the supports.*

To take up the support for the plaster that was lost in taking off the wood lath off the ceiling, ribbed lath was used. What makes this product unique is its high standing ribs that cleat into the plaster in a distinct herring bone type pattern. This configuration is also beneficial for its heavy gage wire stiffeners that run parallel through the sheets. At the walls a paper backed lath was used to keep the fresh plaster from backfilling into the cavities cre-

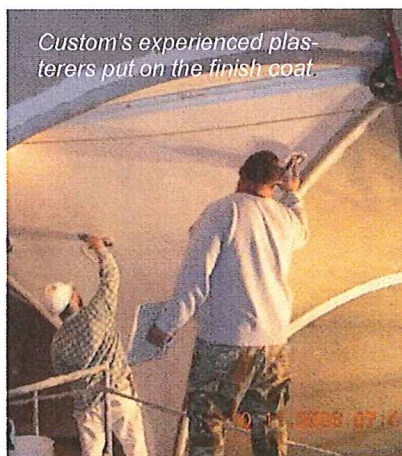
*Custom's experienced plasterers put on the finish coat.*

Where the old plaster had varied in thickness from 3/8" up to 2", it was corrected by modern plastering methods to a consistent thickness of 1". This was important in distributing the weight of the new ceiling more evenly. Plastering craftsman that employed their considerable technical skills included the likes of Greg Gouette and Greg Kannel of Custom's talented staff. Joe Salemi of USG was also instrumental in providing technical guidance along the way in the installation of Red Top gypsum plaster and Black Diamond finishing plaster. "Black Diamond," said Rich, "proved to be a little more forgiving in providing better workability and a little slower set time."

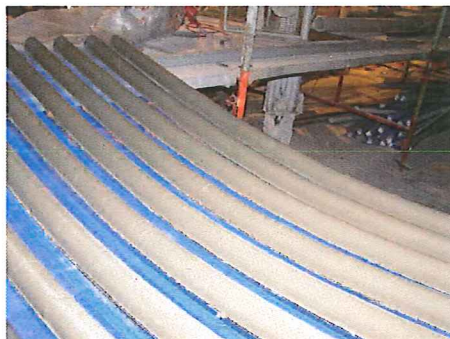
The ornamental work proved to be a process in combining new technology with old. The original molding that divided the vaulted ceiling into distinct panels was as crooked as a bucket of snakes. What seems apparent in the original construction is that given the compound curve configuration and thickness inconsistency of the plaster, a datum line could not be established to which a plaster mold could be run accurately. Nor could the molding be bench fabricated and then stuck in place without segmenting it into very small pieces.

*Expanded polystyrene was used to replicate the rope plaster moldings dividing the vaulted ceiling into panels.*

Custom had a better idea. Based upon their considerable experience in using foam shapes for many EIFS projects over the years, they called upon their association with Dryvit Distributor, Tim Lutz to prefabricate eight foot arching pieces that could be prewrapped with Dryvit synthetic basecoat and reinforcing mesh on the ground and then positioned and fastened into place on the ceiling. Once up, a flap of reinforcing mesh from the new molding was feathered into place over the plaster flatwork with molding plaster for a seamless look. But that wasn't the extent of the issues that confronted Custom Dry-

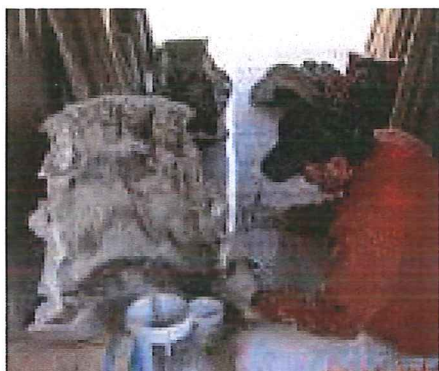
*Making silicone molds of the original capitals with angel sentinels.*

wall: Several ornamental plaster moldings and cornice work had to be fixed and duplicated, including areas of trim under the balcony choir loft. Some of the capitals on top of the columns had to be recreated from molds created from originals out of silicone rubber.
