Pantages Theatre Restoration . Minneapolis

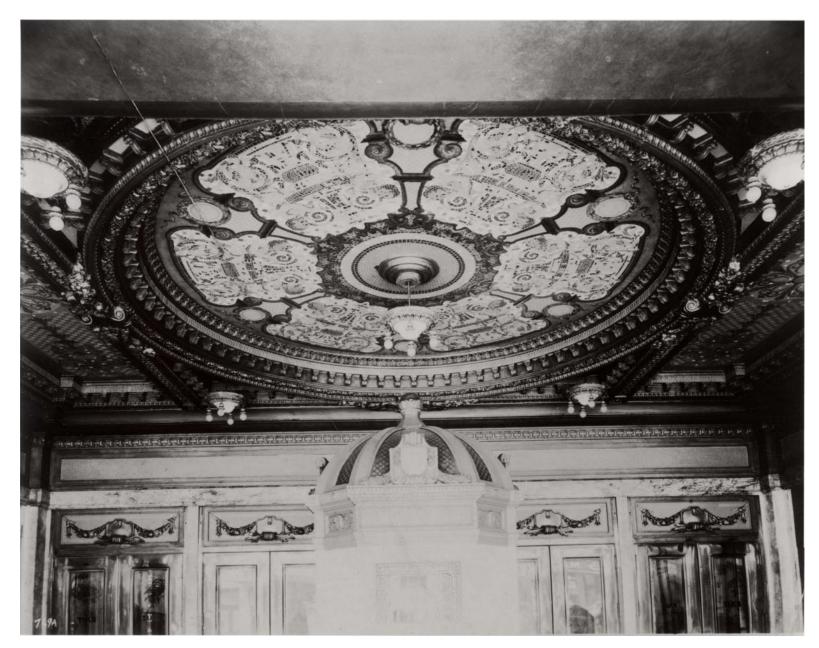
The original lobby was covered but open to the exterior. (1916)

The bar is located where the ticket booth once was

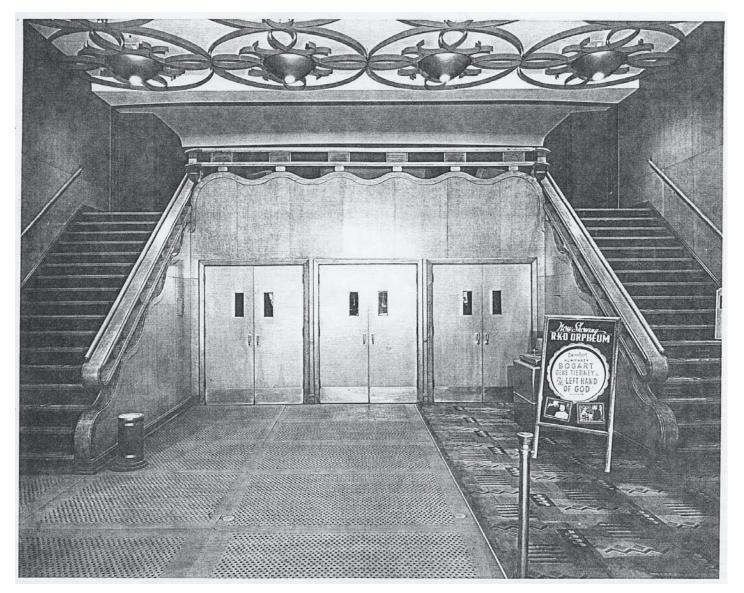
The lobby was extensively remodeled many times over the years....this photo dates back to 1946 opening of the RKO Pan.

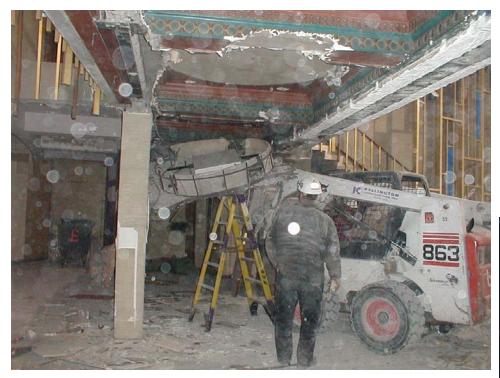
This is the foyer under the mezzanine balcony in the main lobby. The 1961 lay-in ceiling was removed and much to everyone's surprise.....

....behind remnants of the 1947 plaster ceiling, the coffered ceiling from the original lobby was found almost intact.

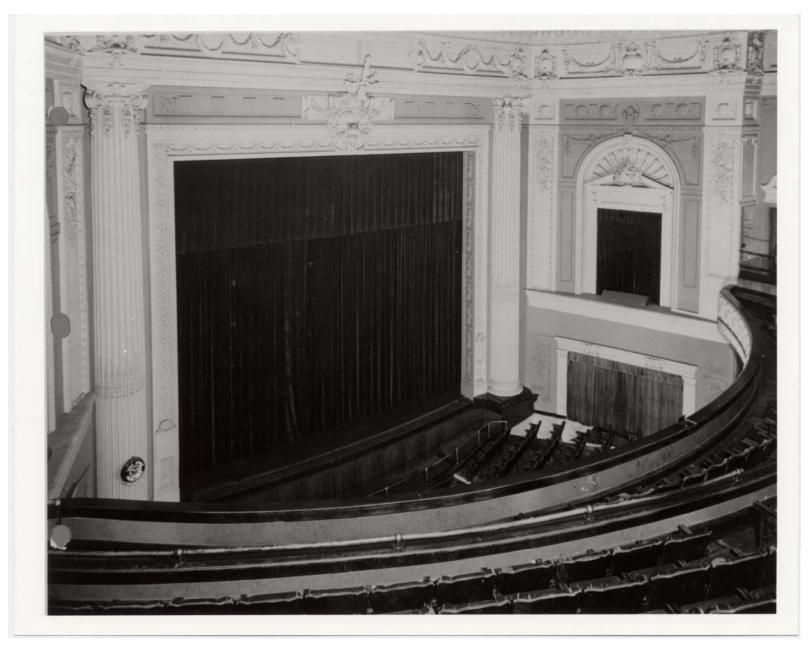
Although the original paint scheme had been covered over, the proscenium and side boxes remained intact until Ted Mann renovated the theater in 1961. (1954)

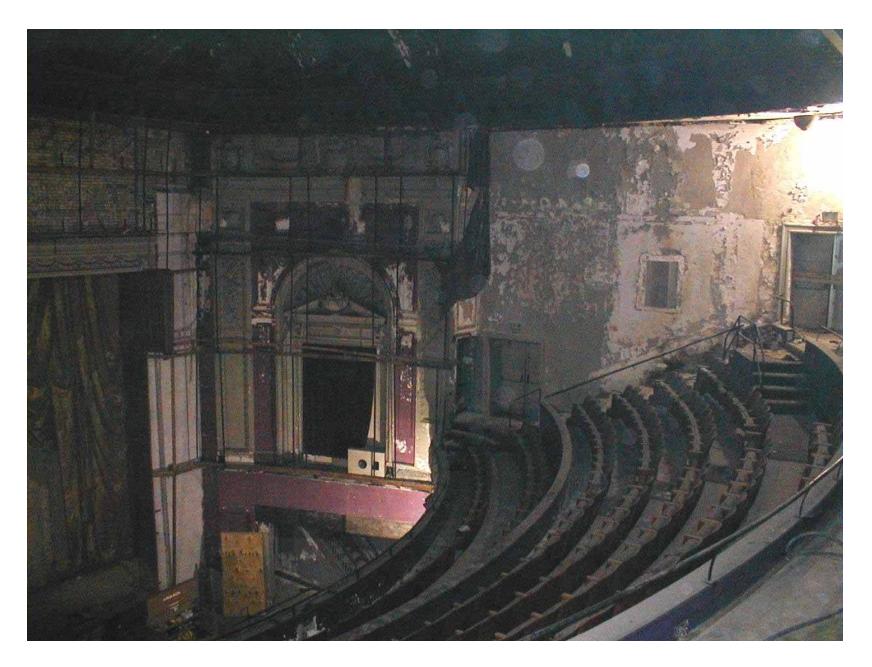
For the 2002 renovation, only the side boxes and ceiling had intact decorative plaster

Most of the decorative plaster, including the flanking columns, was removed. The proscenium and side boxes were completely draped to create a more "modern" look.

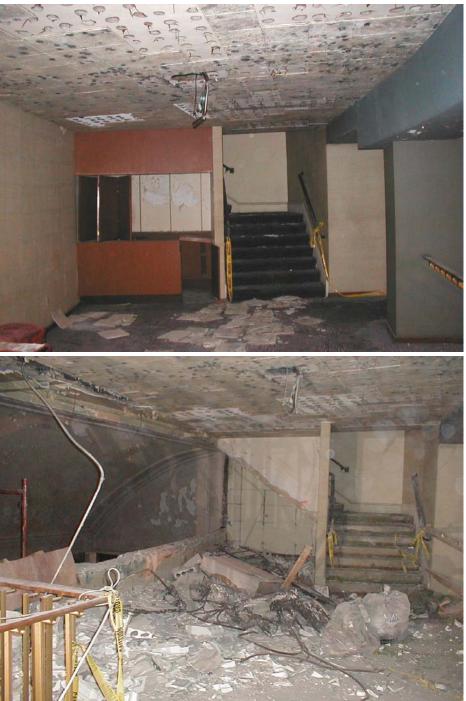
The mezzanine balcony was opened to overlook the main lobby in the 1961 renovation. The new mezzanine lobby is being extended to accommodate the new stair configuration.

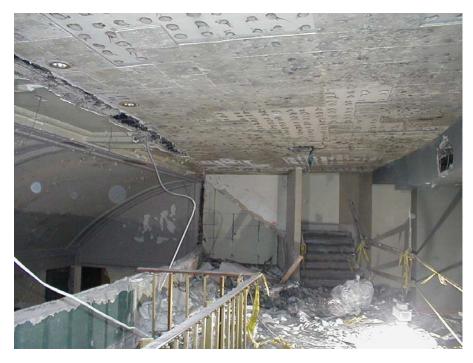
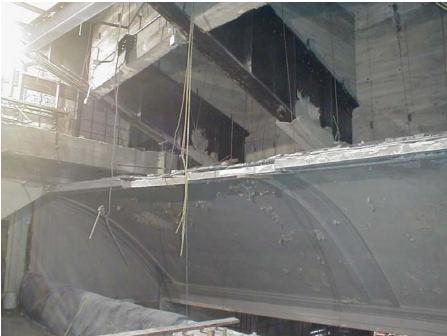
The original decorative plaster framing had previously been removed from the mezzanine balcony ceiling although remnants were discovered behind a "modern" light cove. Ceiling tiles, moldy from years of water infiltration, were glued to the original flat plaster ceiling with mastic. The flat entire ceiling system was demolished and rebuilt.

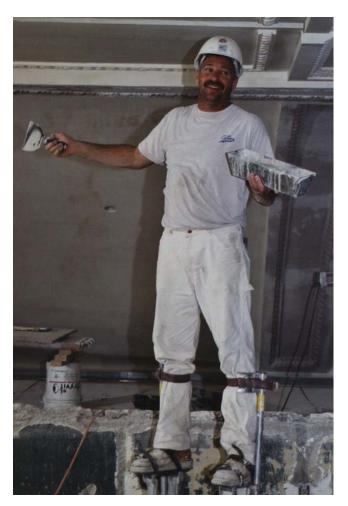
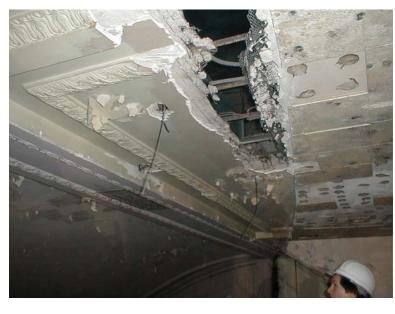
The original decorative plaster framing can be seen to the left of the historical curtain track slot. Plaster framing was created to match existing and a new curtain track was installed.
