Volume 17, Issue 3

New Year 2008

## "Perseverance"

**A Grand River Valley Church is Resurrected from Ashes**

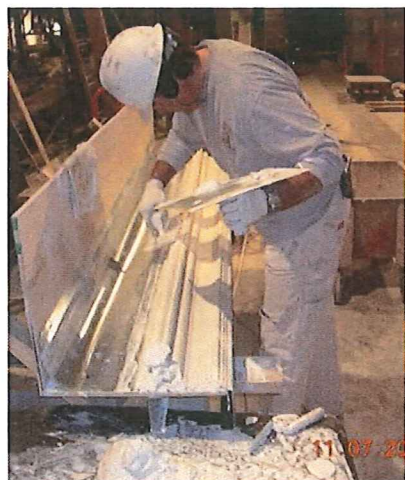
Bases for the columns which could not be saved also had to have new molds made and plaster recast.

Another issue that remained to be addressed was duplicating the plaster columns that proved to be unsalvageable. Again modern technology had an answer for a 150 year old problem. Instead of fixing the columns, new ones were fabricated from fiberglass. But like what was done by hand long ago, plaster was employed to cover the forms and mend the seams between the sections that made up the new columns. Last but not least Custom even played a part in repairing some of the statuary, including the Crucifix that hung above the sanctuary.
